**SPECIAL ENGINEERING SERVICES TO
ESTABLISH INSPECTION CRITERIA FOR
BEARINGS TO IMPROVE LIFE PREDICTION**

FINAL ENGINEERING REPORT

SwRI Project 15-4012

Warner Robins Air Logistics Command
Directorate of Materiel Management
Robins Air Force Base, Georgia 31093

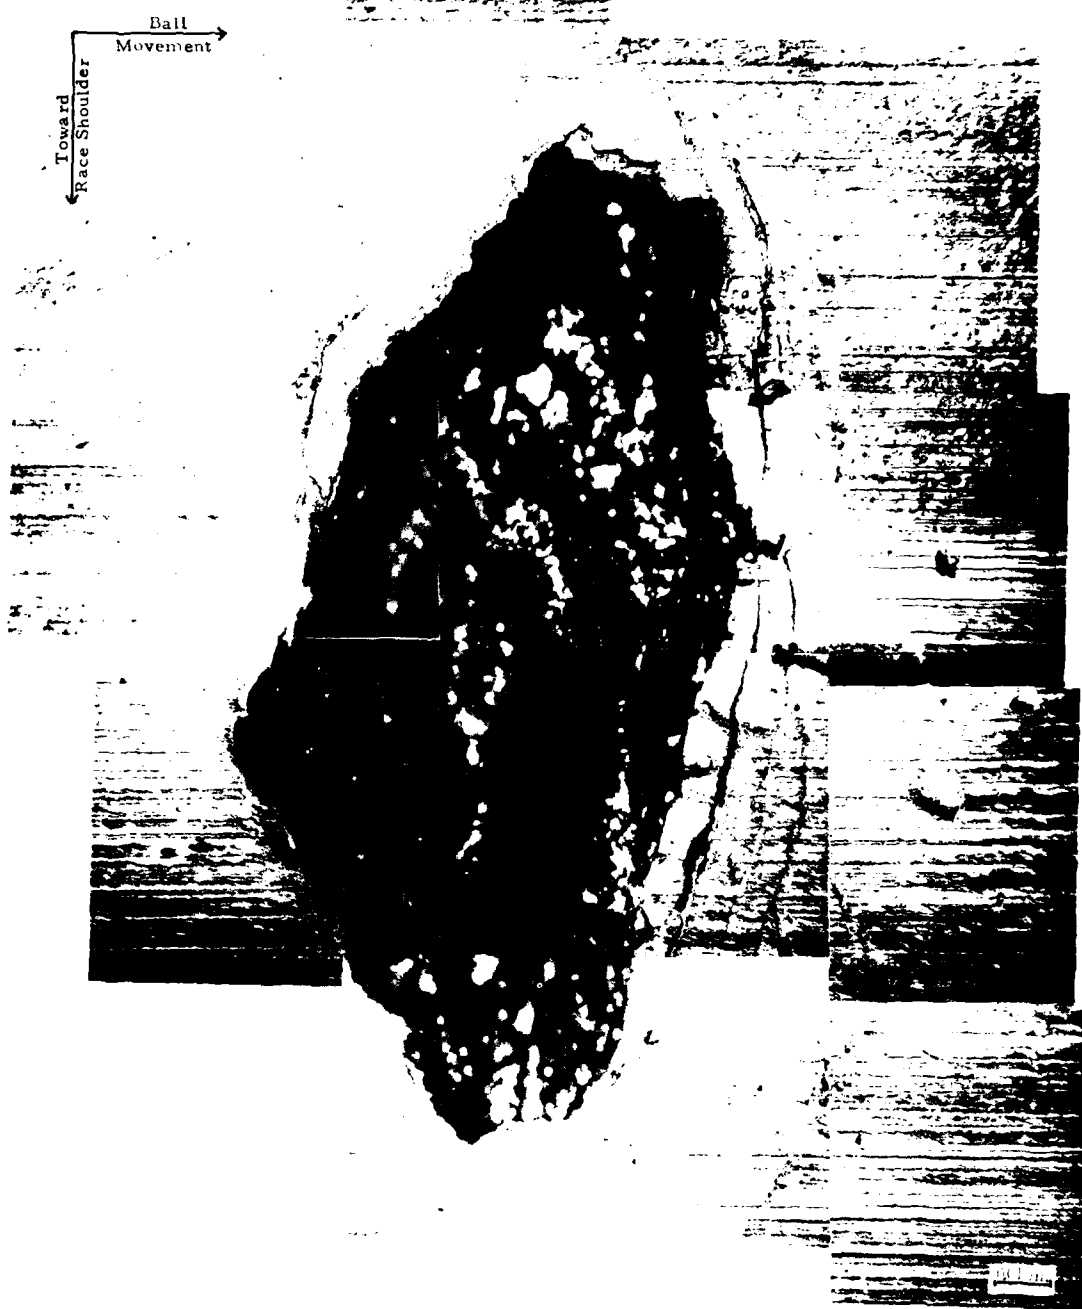
FIGURE 21. SURFACE PHOTOMICROGRAPH OF SPALL REGION ON
J57-#4 INNER BEARING RACE, S/N 219A-2 (S12052-1).

If the failure was a truly randomly originated event, there would be approximately 400,000 unit cells (0.003 in. by 0.003 in.) at the surface within which the failure could have initiated. The fact that it was possible to forecast the precise initiation location even though no prominent anomaly was observed on the surface demonstrates the effectiveness of the CIBLE inspection methodology.

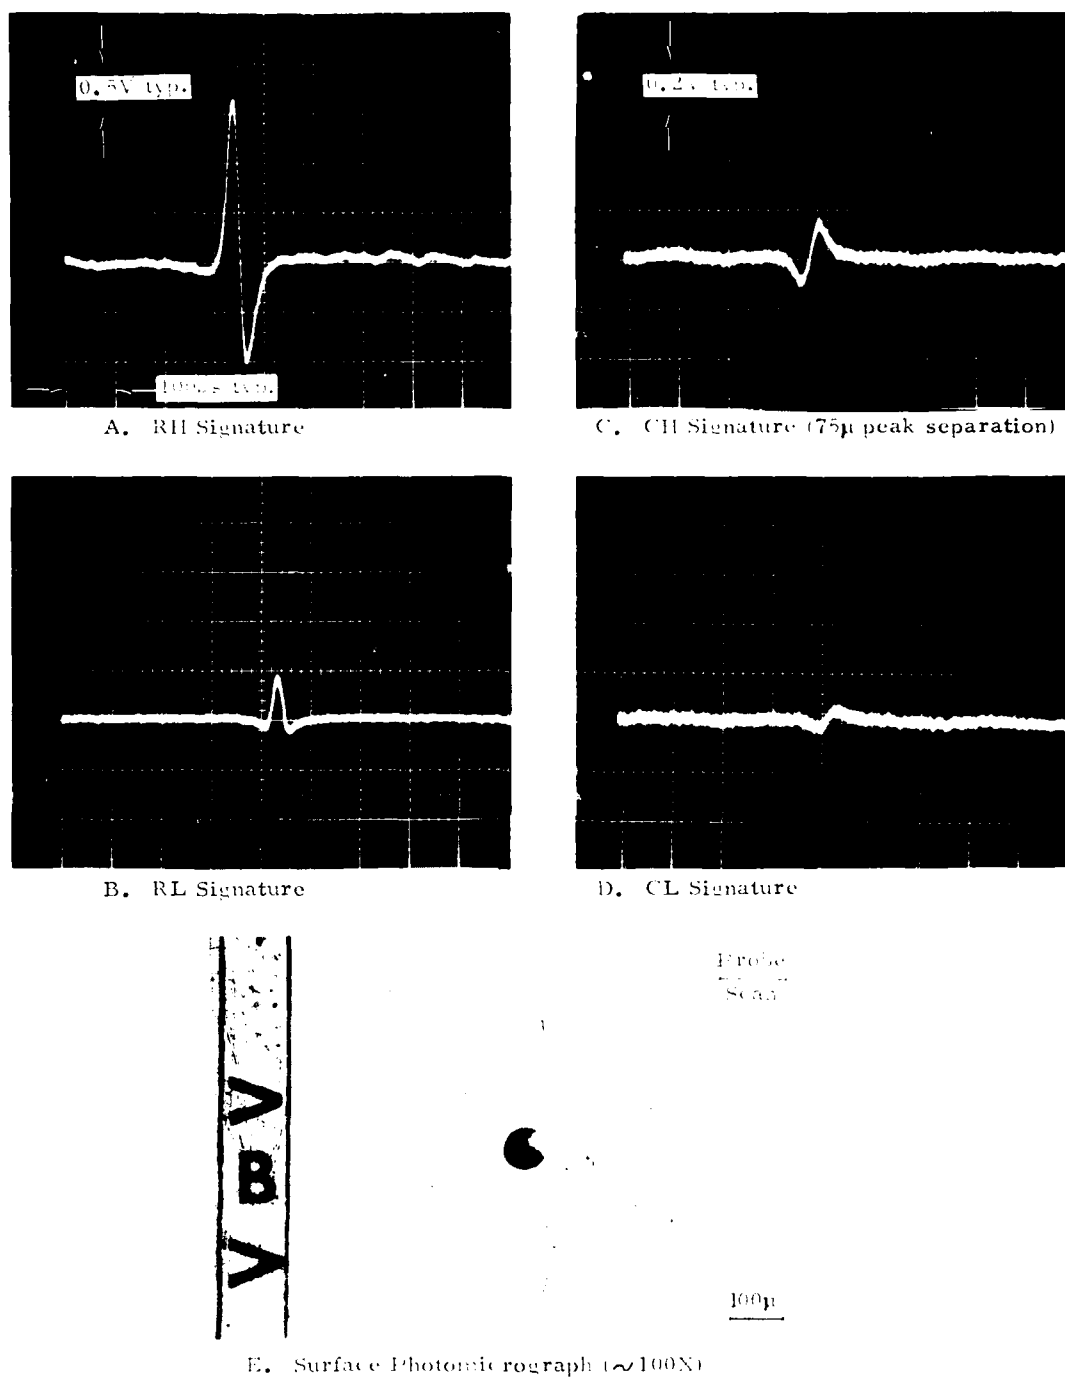
FIGURE 6. CIBLE INSPECTION SIGNATURES AND CORRESPONDING SURFACE PHOTOMICROGRAPH SHOWING INCLUSION ON SURFACE OF NEW BALL FROM VENDOR REWORKED J57-#4 BEARING S/N 3453-2, 5940 HRS (Ball #12, S11092).

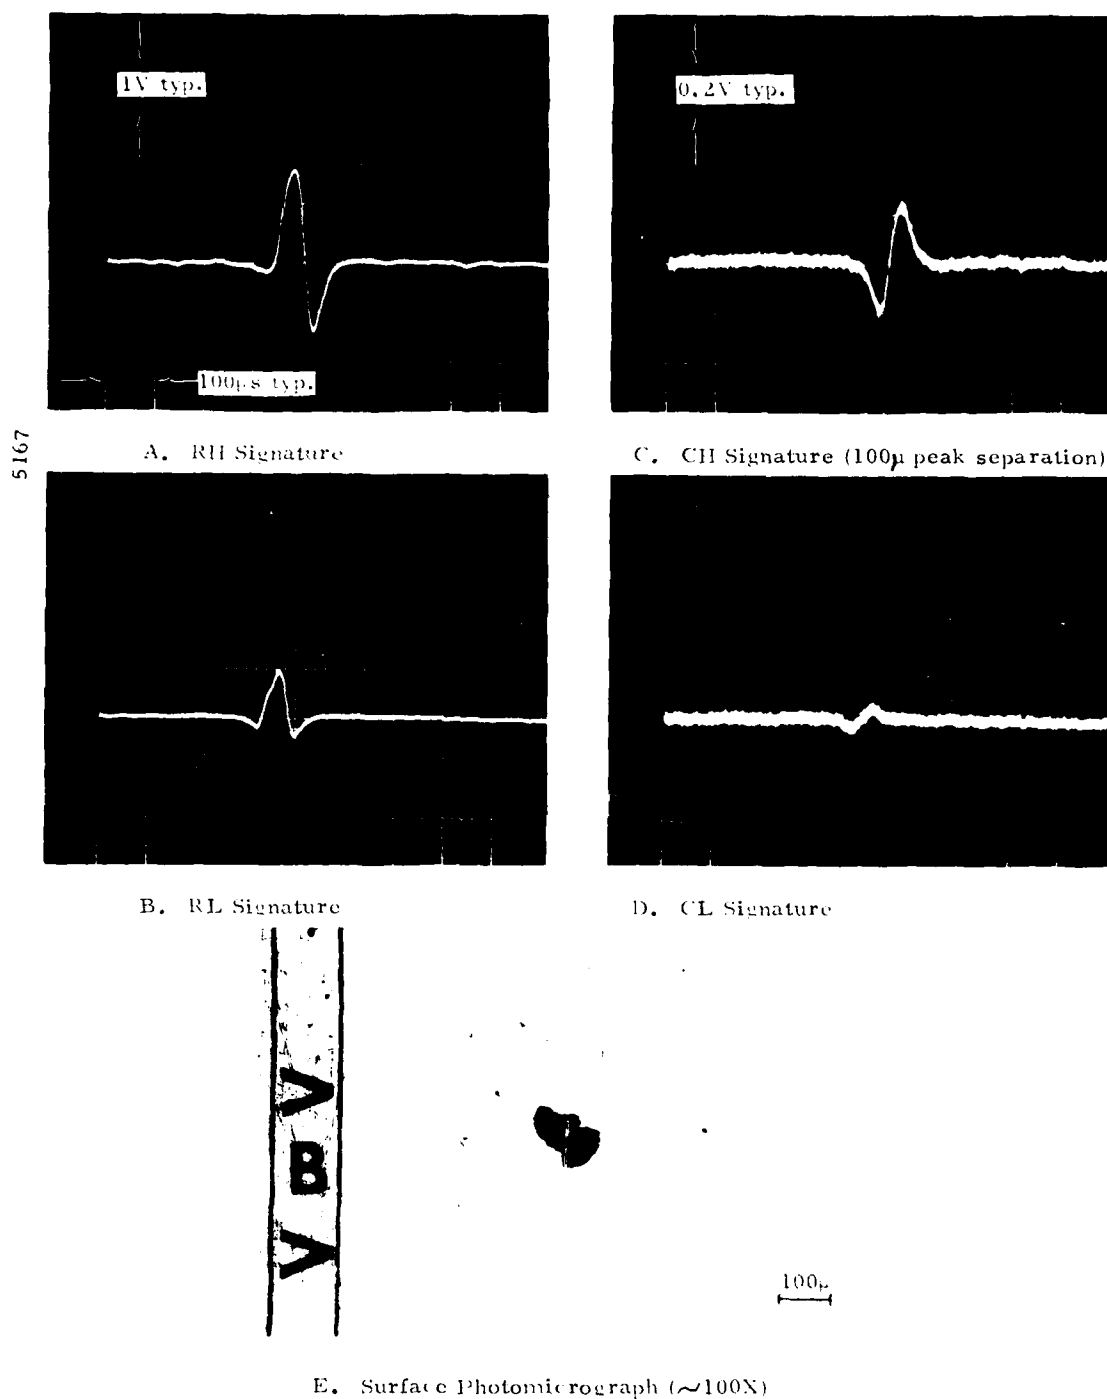
FIGURE 7. CIBLE INSPECTION SIGNATURES AND CORRESPONDING SURFACE PHOTOMICROGRAPH SHOWING INCLUSION ON SURFACE OF NEW BALL FROM VENDOR REWORKED J57-#4 BEARING S/N 3453-2, 5940 HRS (BALL #13, S11092).

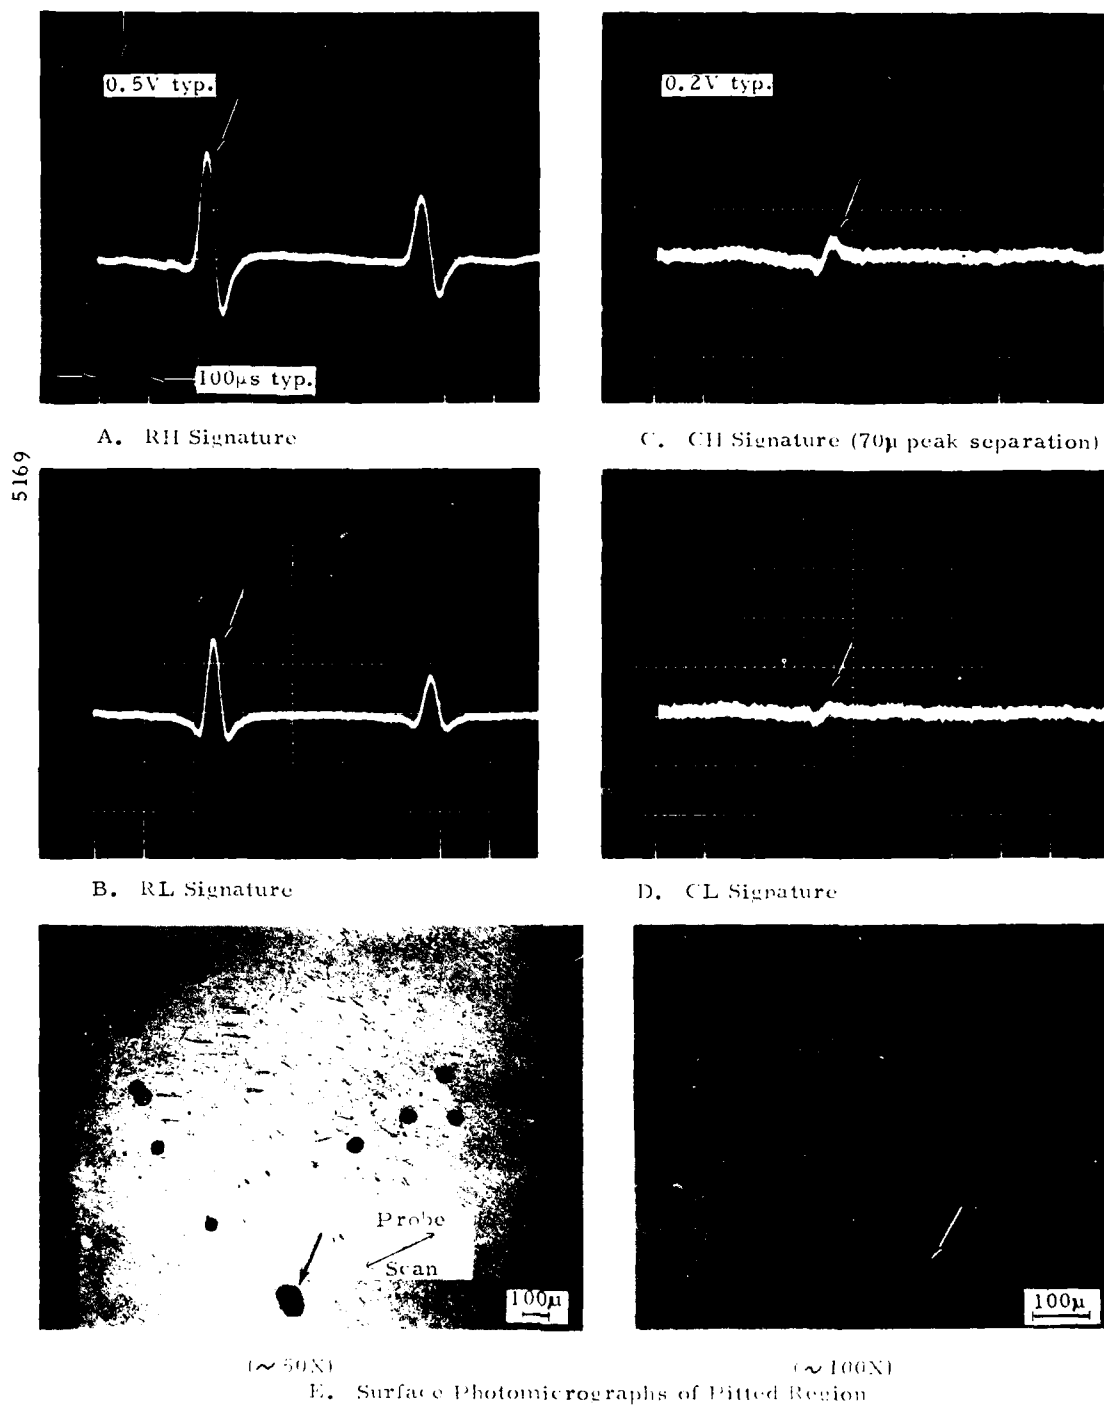
FIGURE 8. CIBLE INSPECTION SIGNATURES AND CORRESPONDING SURFACE PHOTOMICROGRAPHS SHOWING PITTED REGION ON NEW BALL FROM VENDOR REWORKED J57-#4 BEARING S/N 3083-2, 4769 HRS (Ball #7).

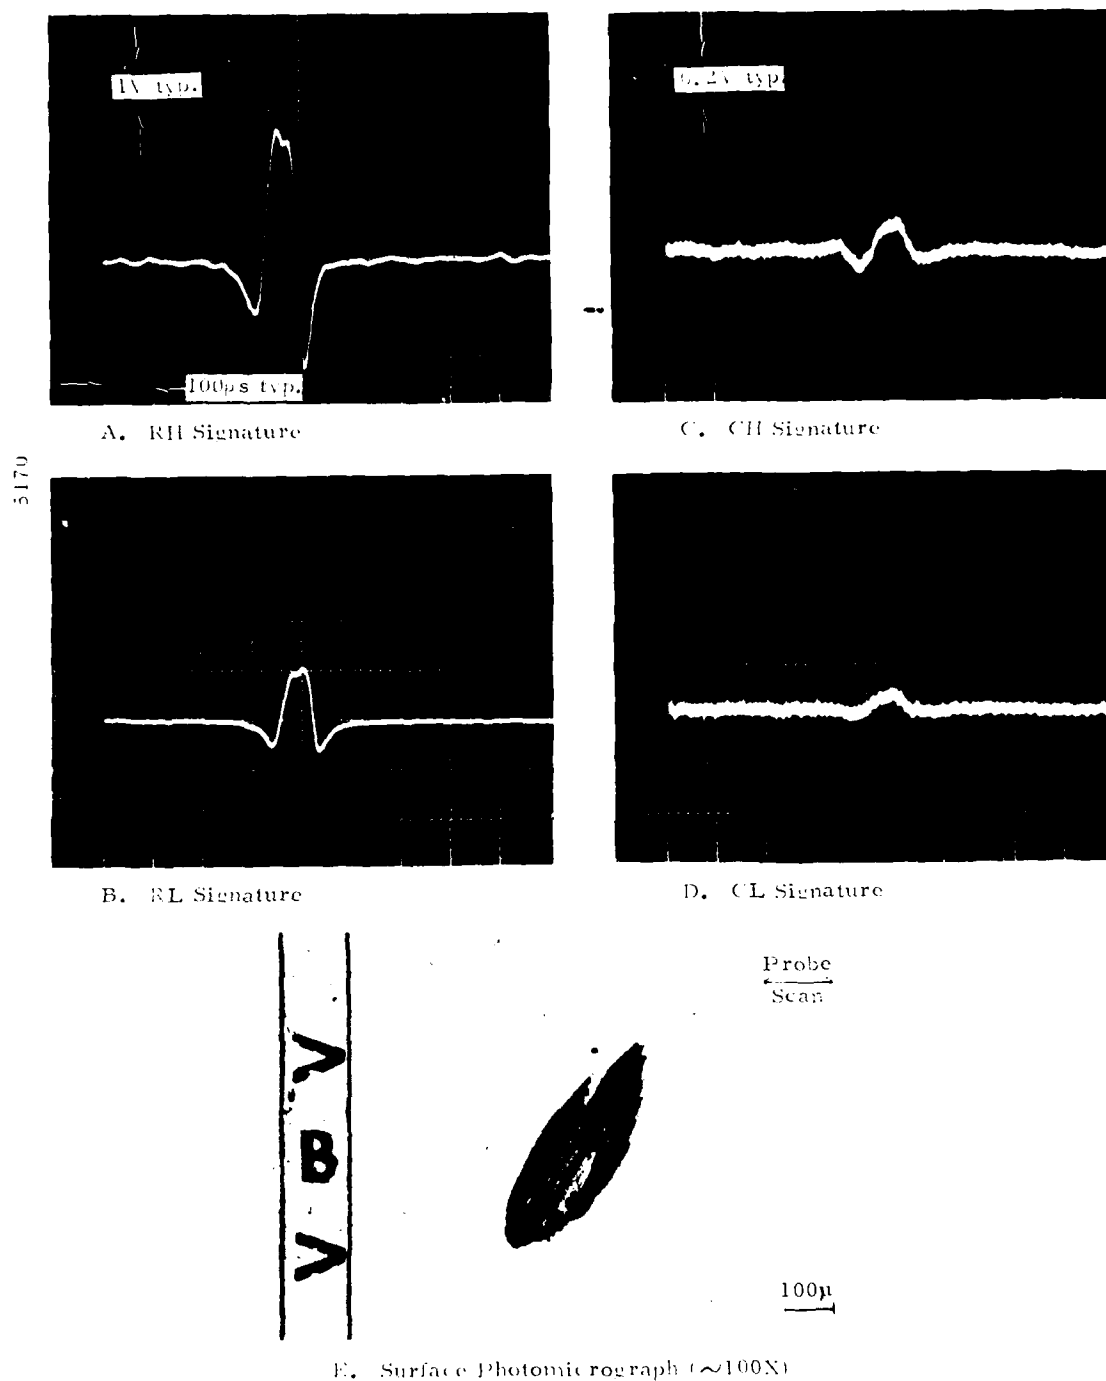
FIGURE 11. CIBLE INSPECTION SIGNATURES AND CORRESPONDING SURFACE PHOTOMICROGRAPH SHOWING GOUGE ON NEW BALL FROM VENDOR REWORKED J57-#4 BEARING S/N 9293-1, 6651 HRS (Ball #4, S11931).

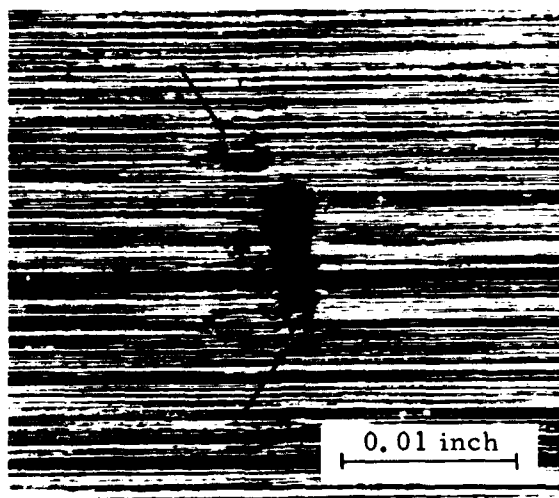
Magnified (100X) View of Surface Showing the Flaw that Caused the CH and RH Signatures

FIGURE F2. CIBLE RESULTS ON J57-#2 BEARING (S/N B1274-2) INNER RACE
 (Reworked bearing accepted by Air Force and considered
 equivalent to new bearing.)
